# Identifying and Fixing Hardware & Software Faults

Unit 13: P4, P5, P6, M2, M3; Partially covers P2

Unit 25: P5, P6, M2, M3, D1, D2; Partially covers P4

Richard Hancock

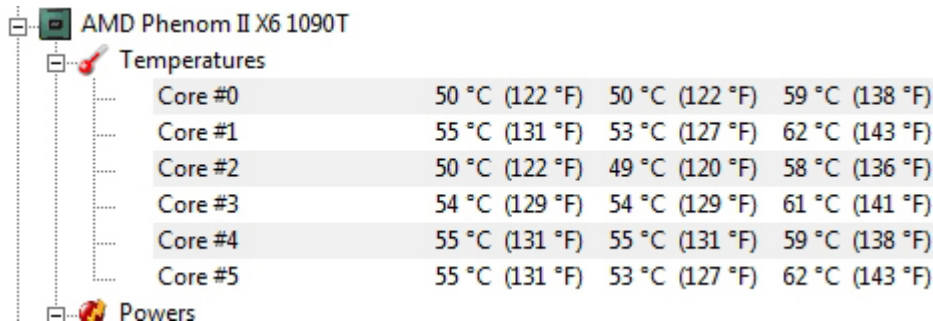
AMD Phenom II X6 1090T			
Temperatures			
Core #0	50 °C (122 °F)	50 °C (122 °F)	59 °C (138 °F)
Core #1	55 °C (131 °F)	53 °C (127 °F)	62 °C (143 °F)
Core #2	50 °C (122 °F)	49 °C (120 °F)	58 °C (136 °F)
Core #3	54 °C (129 °F)	54 °C (129 °F)	61 °C (141 °F)
Core #4	55 °C (131 °F)	55 °C (131 °F)	59 °C (138 °F)
Core #5	55 °C (131 °F)	53 °C (127 °F)	62 °C (143 °F)
Powers

These temperature seem abnormally high for an AMD processor as they are designed to run at lower temperatures. After a search for the model number on google "AMD Phenom II X6 1090T" I found that the maximum operating temperature was between "55°C - 62°C". [\[1\]](#)

That means that the processor is hovering a few degrees below its max operating temperature while idle, which means that when running programs or games that will significantly increase the load on the processor, the temperature will be way above its max.

After looking at the results of the analysis I recommend that a new cooler is needed to replace the faulty cooler.

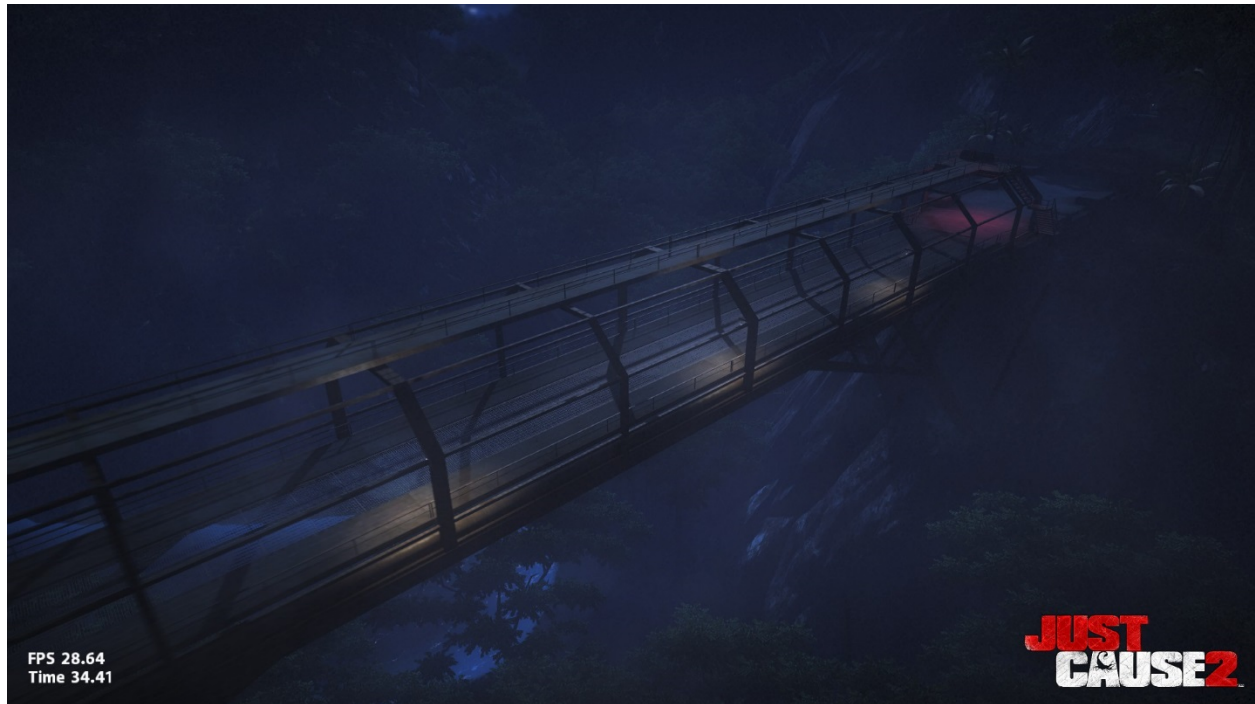
Next I ran some high end games for a few minutes to see what the temperature would reach. Just Cause 2 has a built in benchmarking mode that will create some complex graphical scenes that will stress the GPU and CPU to run. However while running this test I had to be careful of the temperature being too high for an extended period of time, because this could significantly shorten the lifespan of the processor.

*Just Cause 2's Benchmark Mode*

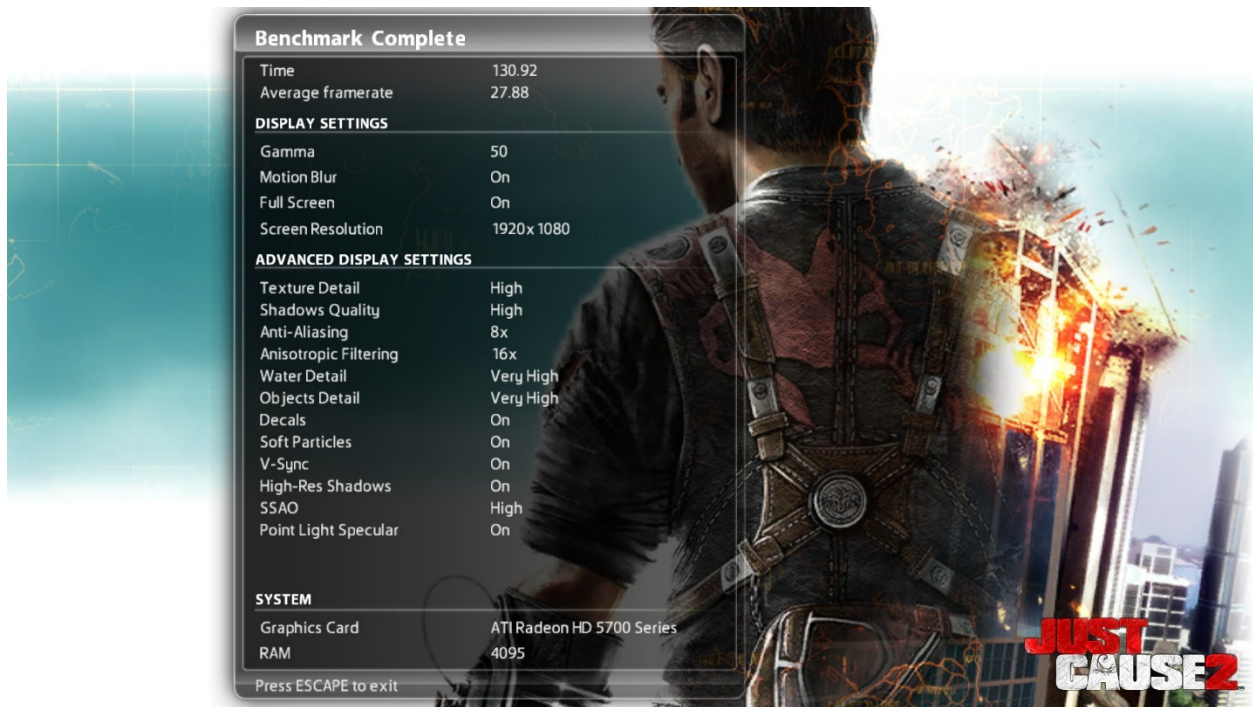
Just Cause 2 Benchmark Results

System Fan 3	100 %	100 %	100 %
AMD Phenom II X6 1090T			
Temperatures			
Core #0	86 °C (186 °F)	84 °C (183 °F)	86 °C (186 °F)
Core #1	87 °C (188 °F)	85 °C (185 °F)	88 °C (190 °F)
Core #2	83 °C (181 °F)	79 °C (174 °F)	84 °C (183 °F)
Core #3	84 °C (183 °F)	81 °C (177 °F)	86 °C (186 °F)
Core #4	87 °C (188 °F)	85 °C (185 °F)	88 °C (190 °F)
Core #5	87 °C (188 °F)	81 °C (177 °F)	88 °C (190 °F)
Powers

I had to stop the test slightly early because the above temps were way too high. The temperature monitoring program also showed that the fan was only spinning at 2000RPM which is pretty slow for an AMD stock cooler. After looking on the internet I found that the max speed of this fan was 6000-7000 RPM. This means that the fan on the stock cooler is faulty and needs to be replaced. The stock cooler could be fixable by dismantling the fan (maybe replacing the bearings or motor), but it would probably easier and more efficient to just replace it with an aftermarket cooler.

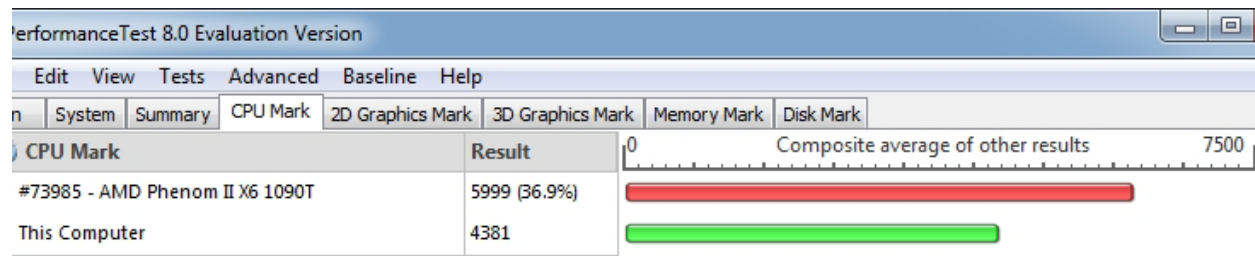
These results show that the processor is running at 63.1% of its potential.

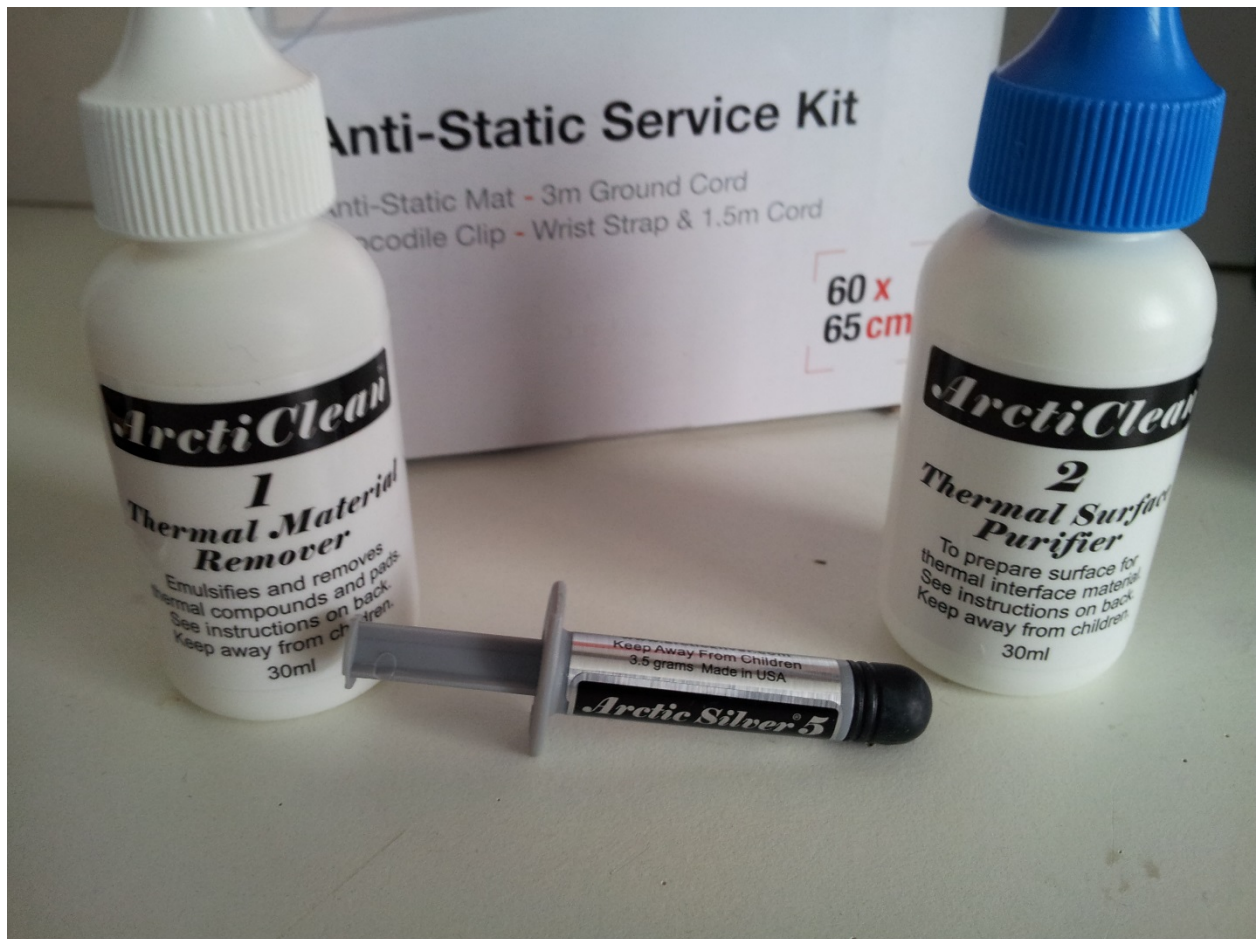
I have found a combo pack of these items with high quality "Arctic Silver 5" thermal paste. [\[4\]](#)

Also pictured above is the anti-static service kit needed to carry out this repair safely without any static damage to the components. [\[5\]](#)

Another item that is needed is some high quality Thermal Paste to efficiently transfer the heat from the CPU to the cooler Also some thermal paste remover to get rid of the previous thermal paste and purify the surface.

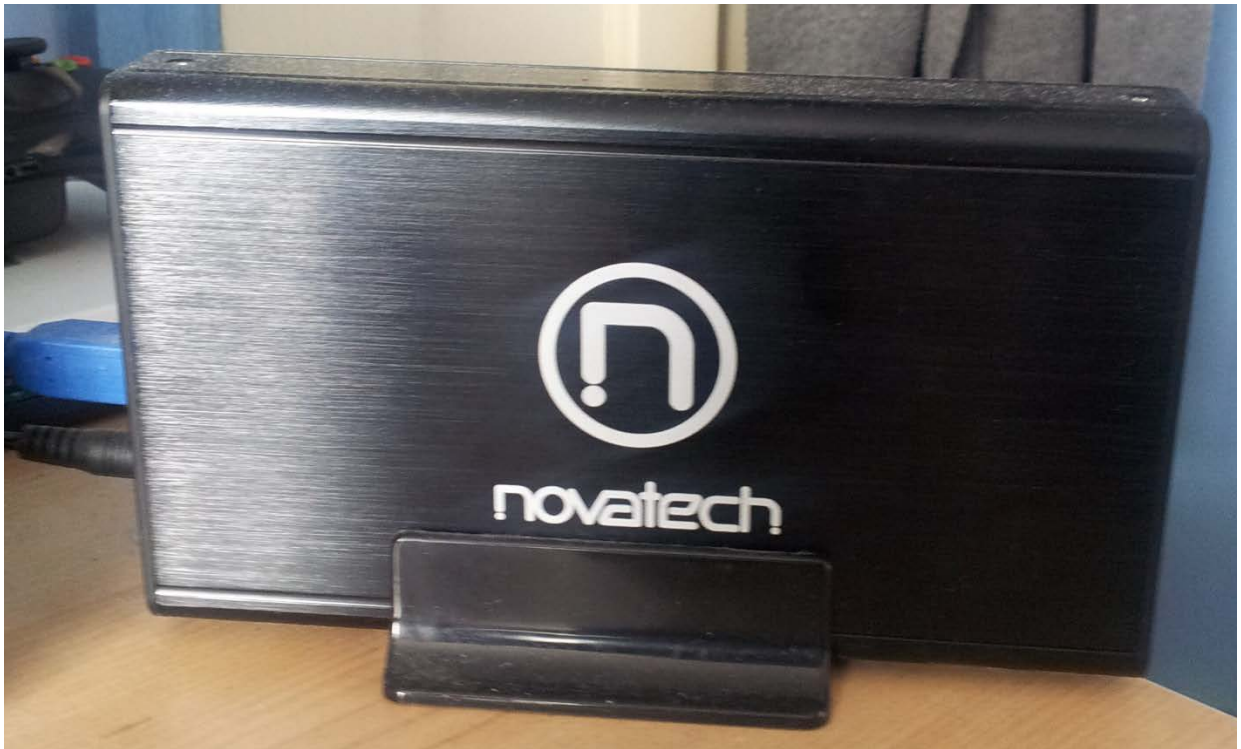
*External Hard Drive Enclosure*

Before performing any upgrades to the computer, I made a backup on an external hard drive of all the data on the hard drive, especially irreplaceable data i.e. personal pictures, videos, documents and saves. I copied all of the files from the user folder to the external hard drive which covers most of the irreplaceable data and left most of the program files, as these can be easily reinstalled/downloaded. While performing this upgrade there is a very low chance of file loss as the hard drive will not be moved or interacted with in any way.

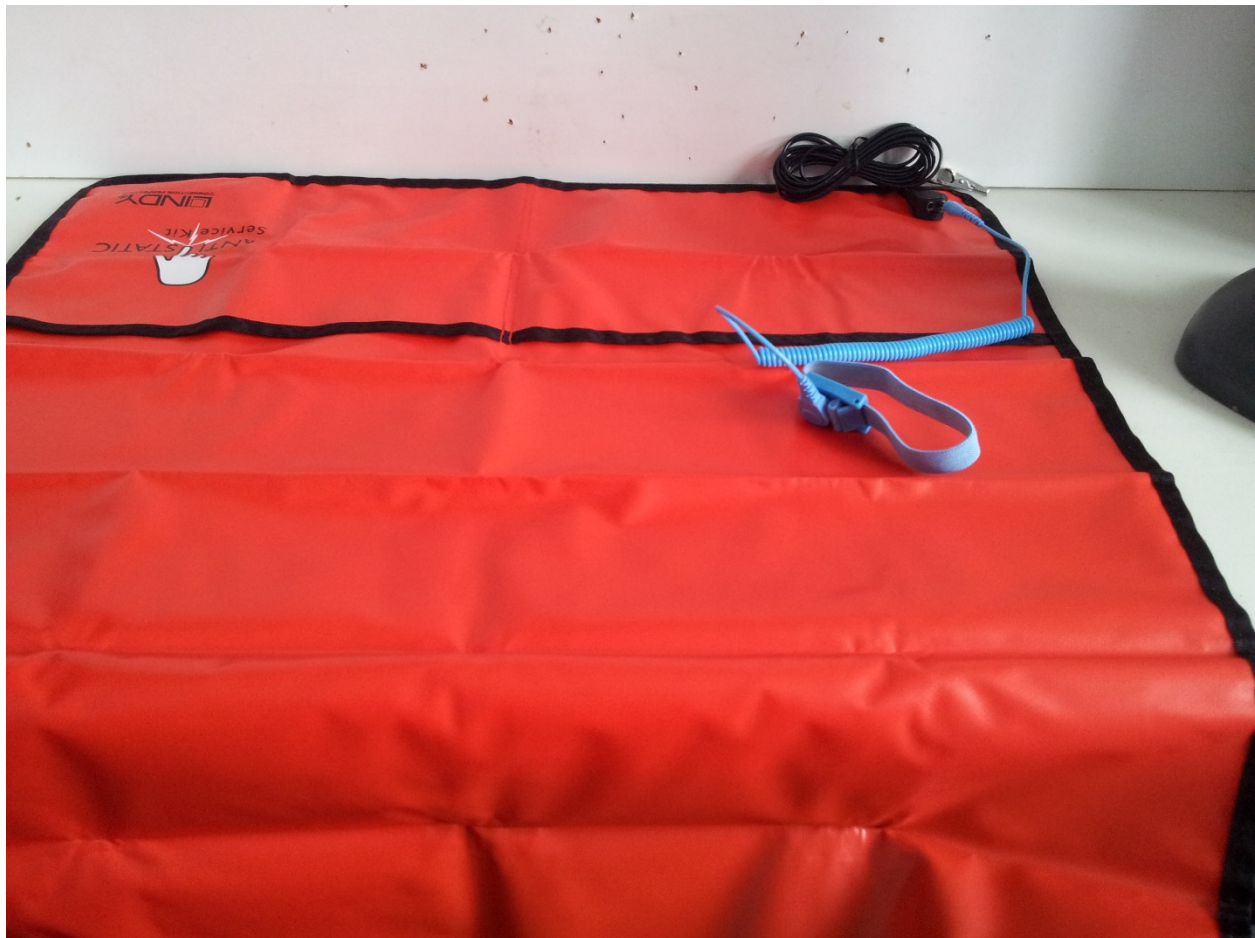
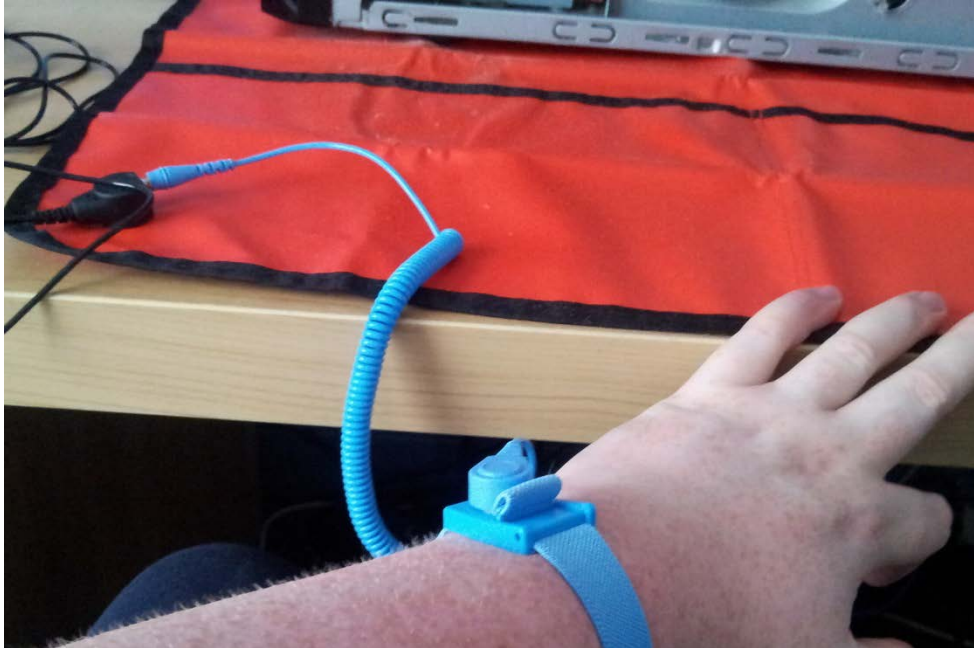
I also had to set up the anti-static precautions to protect the computer equipment from ESD (Electrostatic Discharge). This involved laying out the ESD mat and connecting the black grounding wire to a suitable location. Ideally the ground would be connected to the ground on a plug socket, but I didn't have the ability to do this so I connected the ground to an object with a lower electrical resistance. The ESD mat also had a wrist strap that grounded me as well and the computer equipment.

*ESD Wrist Strap connected to ESD Mat and ground*

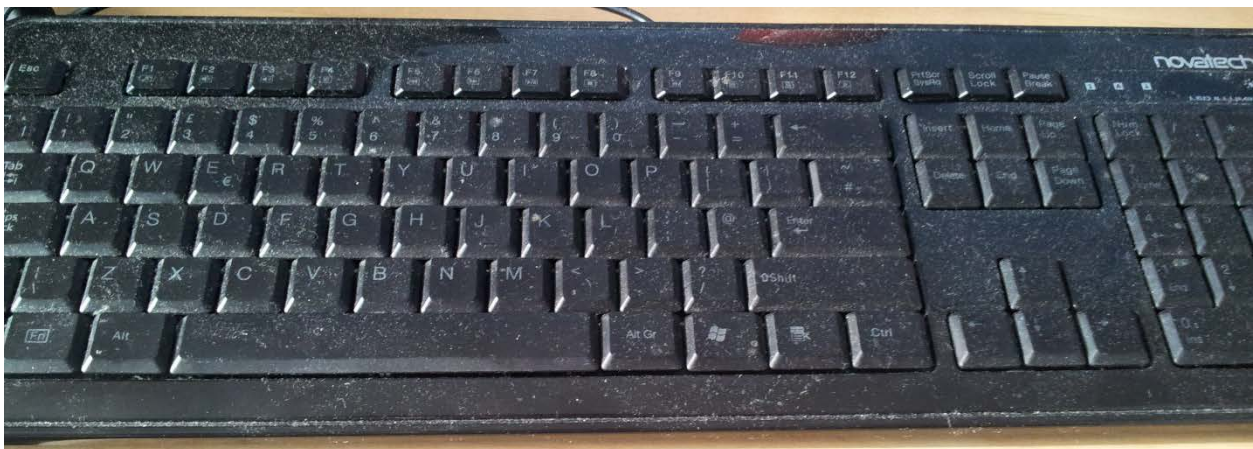
*Keyboard Before*

Unfortunately the keyboard had been stored in a cupboard for a while, so most of the dust was deeply ingrained.

I used a micro-fiber cloth and a damp cloth to clean most of the exterior of machine and accessories. While I used a can of compressed air to clean the vents, fans and interior.

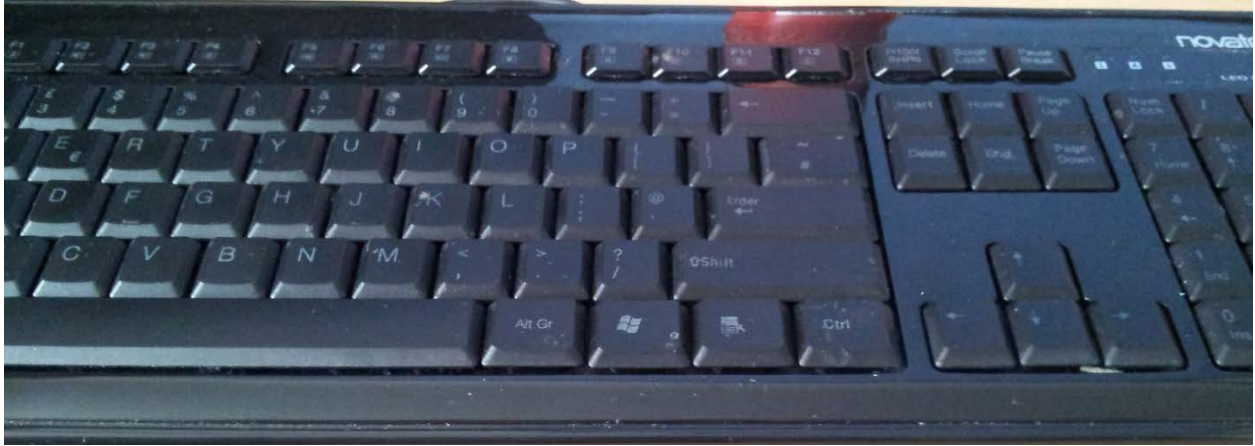
*Keyboard After*

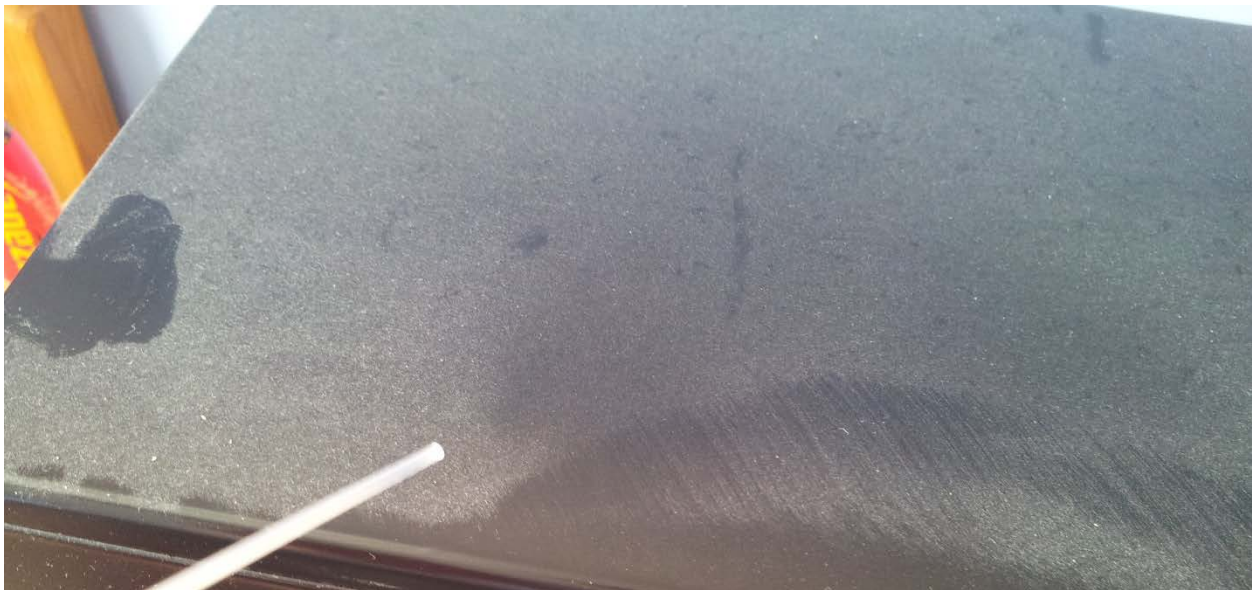
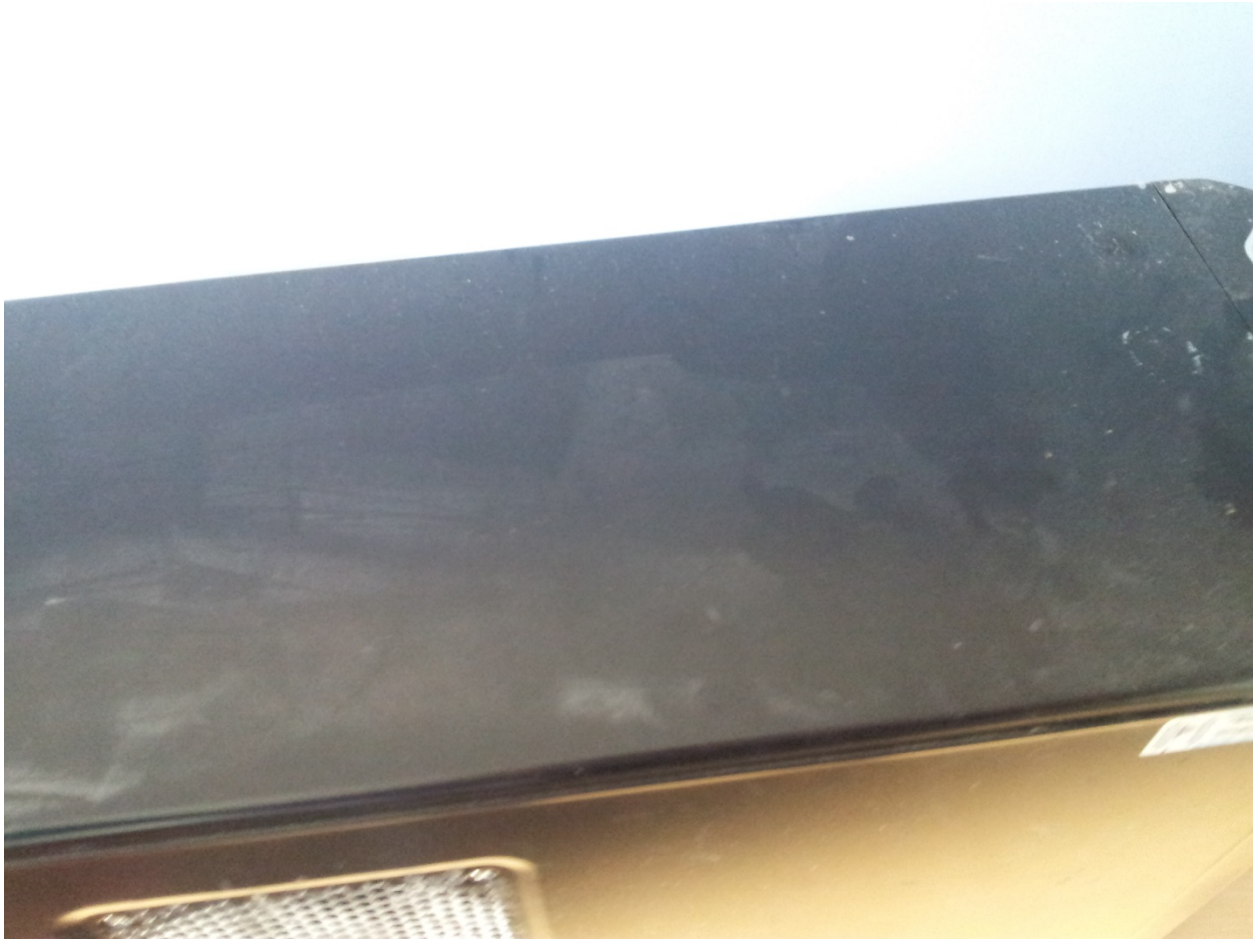
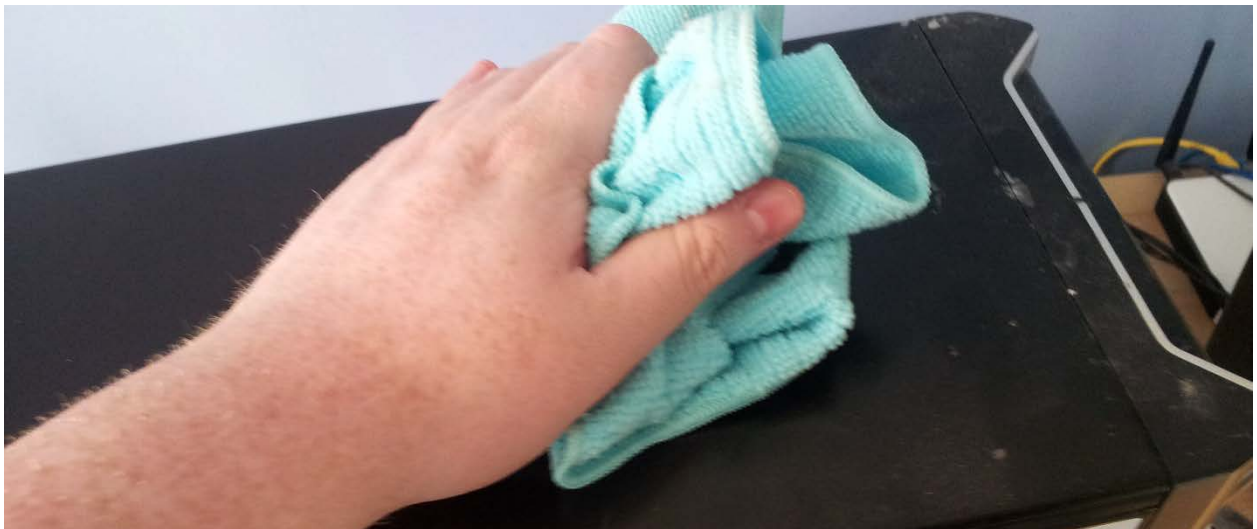
*Cleaning in progress*

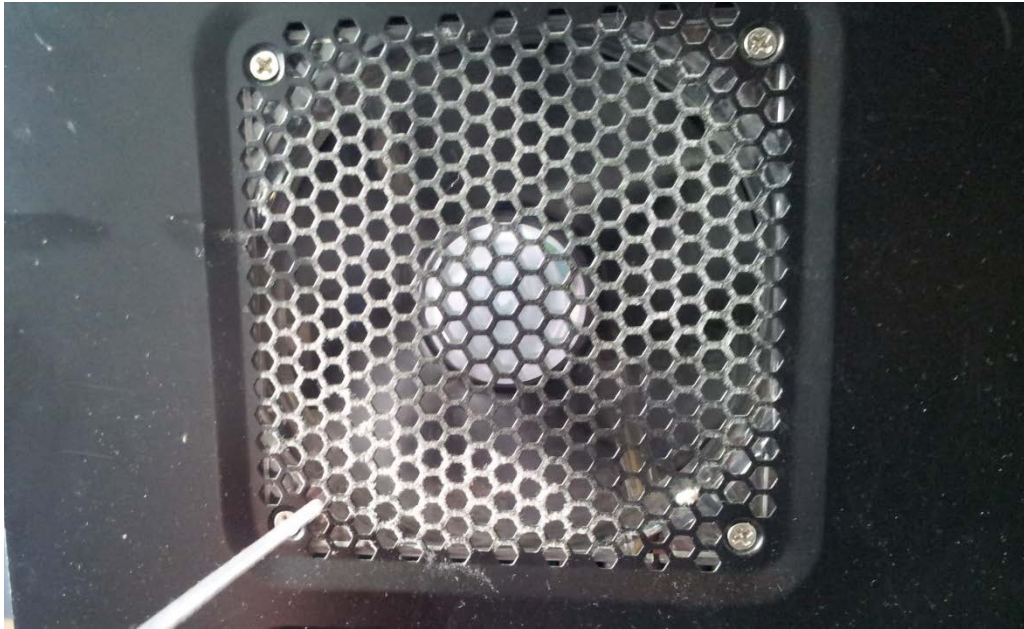
*Cleaning in progress*

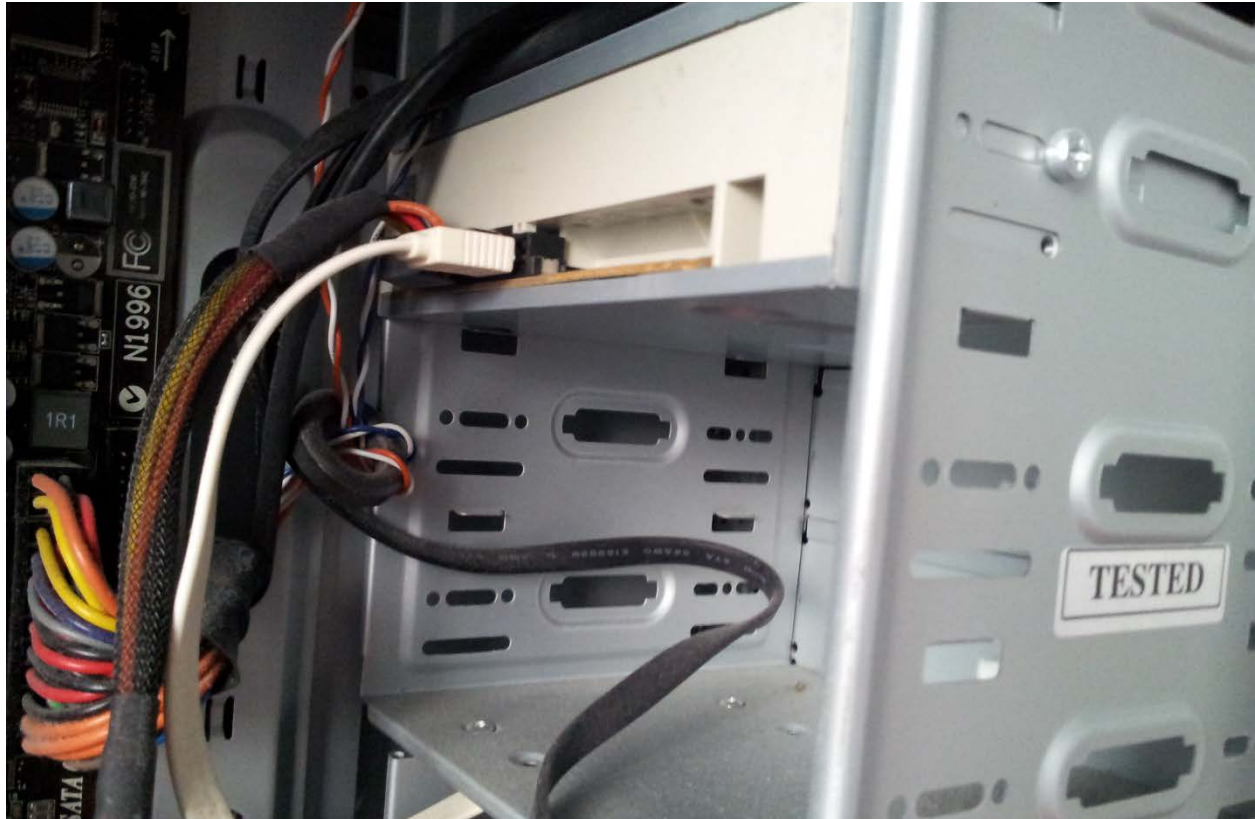
*After Picture (No before picture for this part unfortunately)*

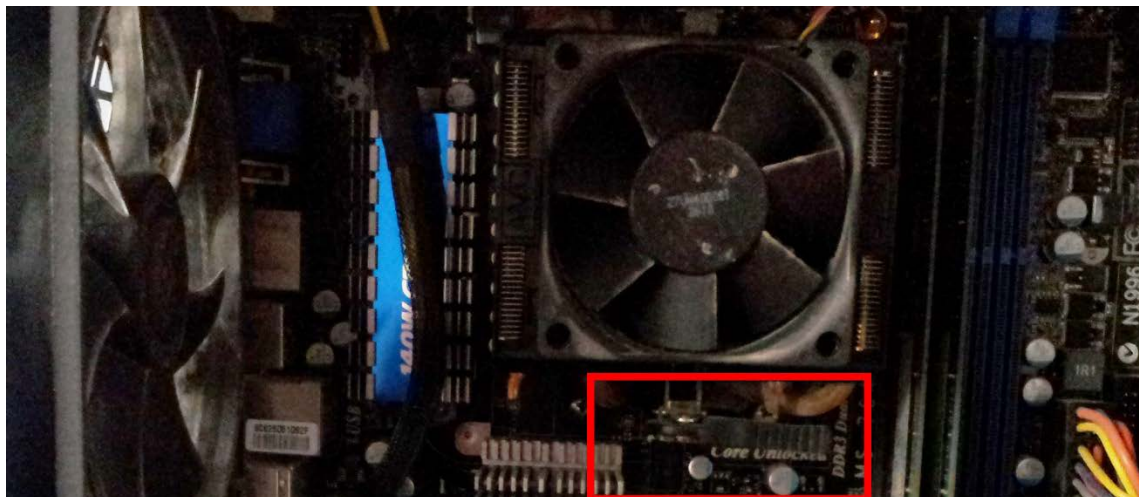
*Picture of Faulty CPU cooler, with the latch highlighted in red.*

Once the cleaning was finished to an acceptable standard, I started the repair process. First I removed the faulty CPU cooler by releasing the lock latch and pushing the cooler down slightly to relieve pressure on the clips that hold it in place.

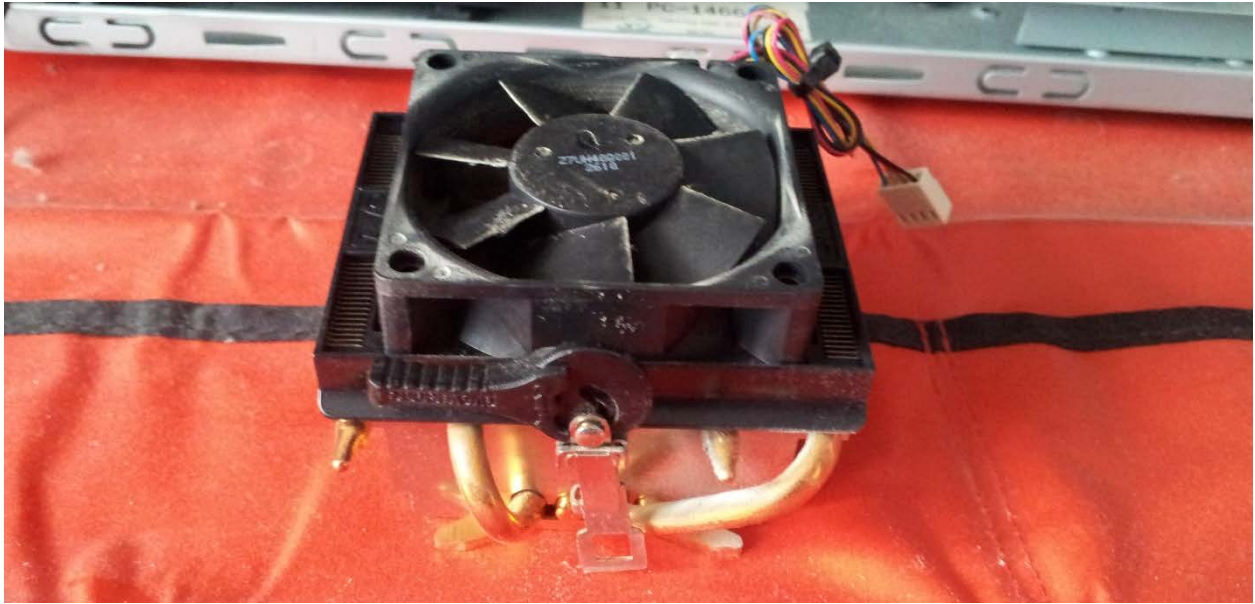
*Picture of the faulty CPU cooler removed*

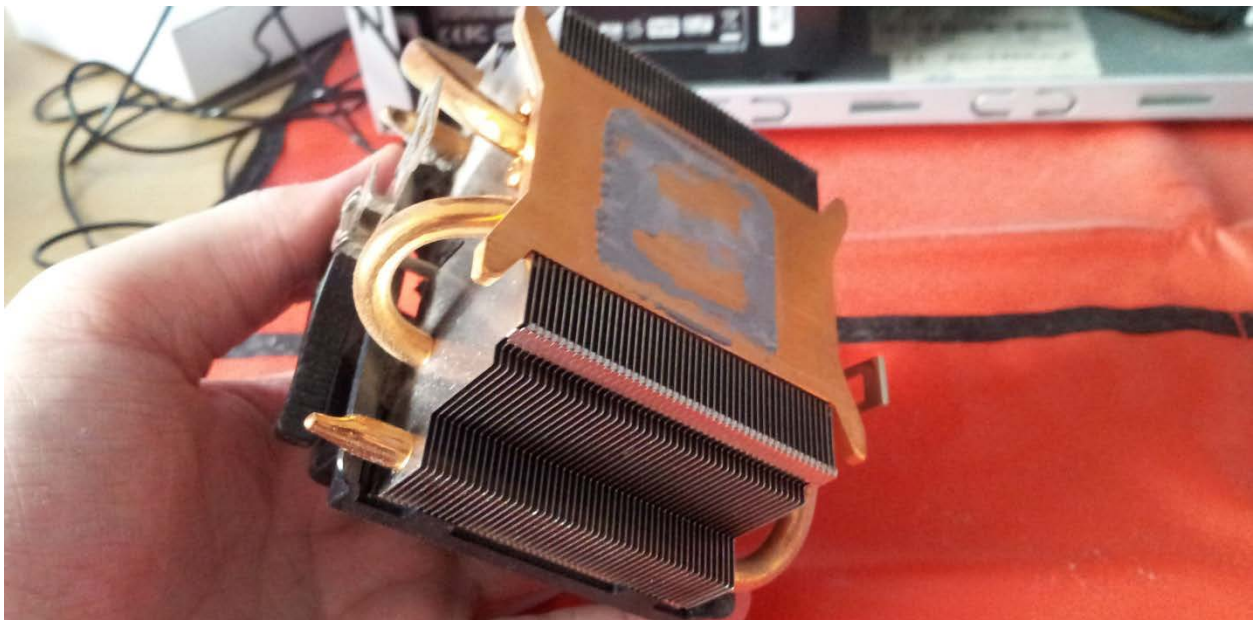
*Picture of the faulty CPU cooler removed, also seen is thermal paste residue.*

The CPU was still covered in a lot of thermal paste residue that needed to be cleaned with the special cleaning fluid brought earlier. This should make the CPU look good as new and be ready for a new coat of thermal paste.

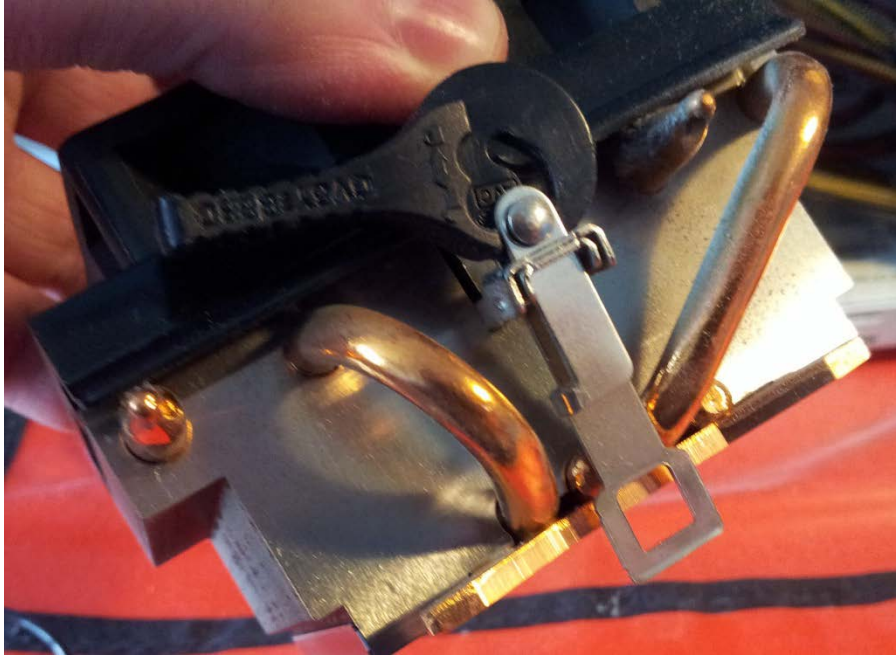
*Close up of the latch and clip that I was talking about earlier.*

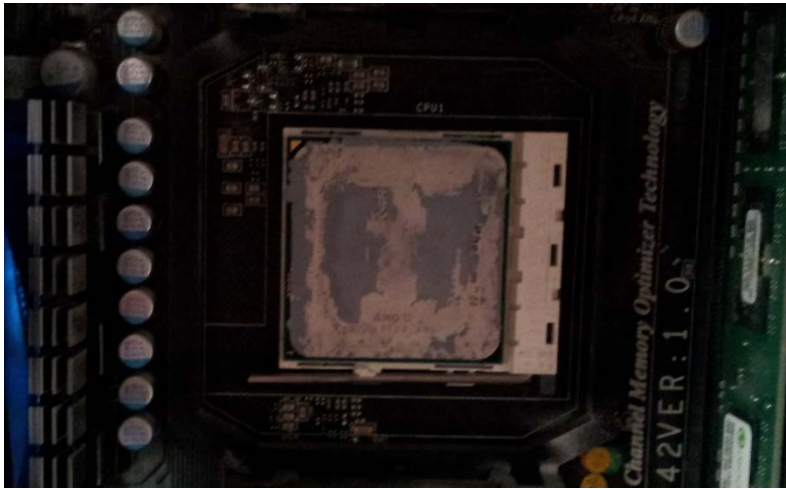
*CPU before any cleaning*

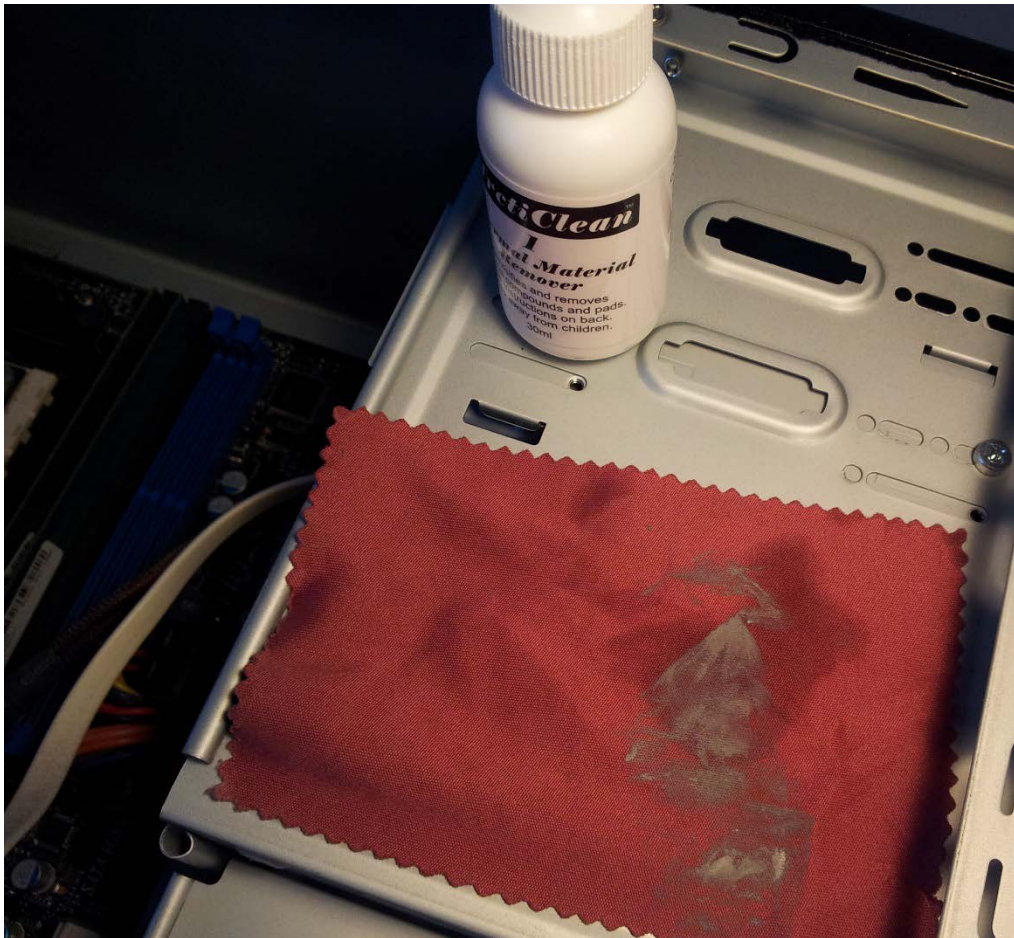
*Using the Thermal Paste remover and a lint free cloth, I started wiping away the Thermal paste*

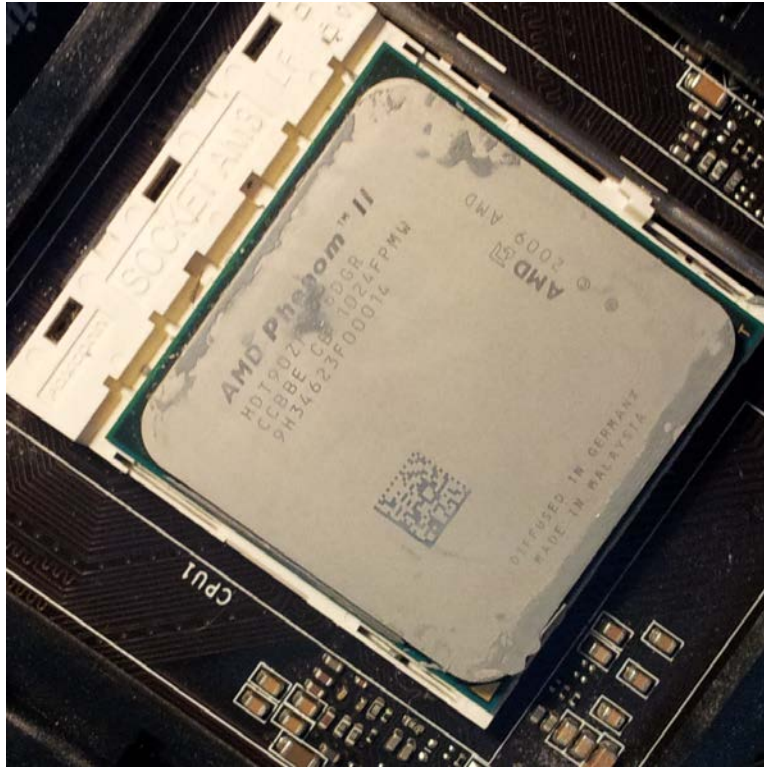
*CPU after 1st cleaning fluid applied.*

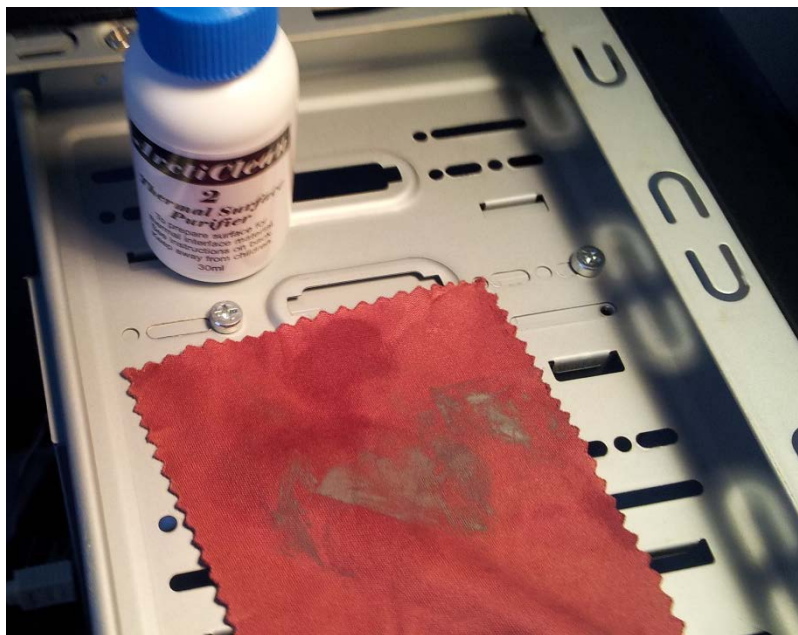
*I then applied the second fluid using the other side of the same lint free cloth*

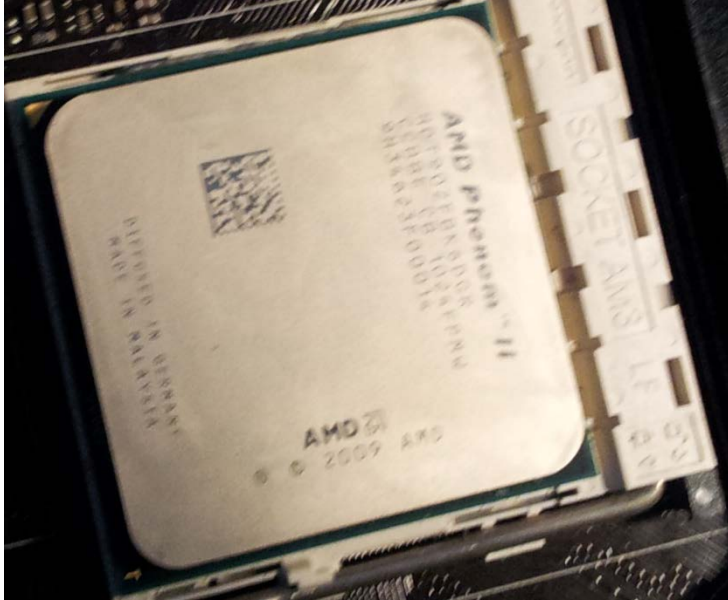
*The CPU is now ready for thermal paste*

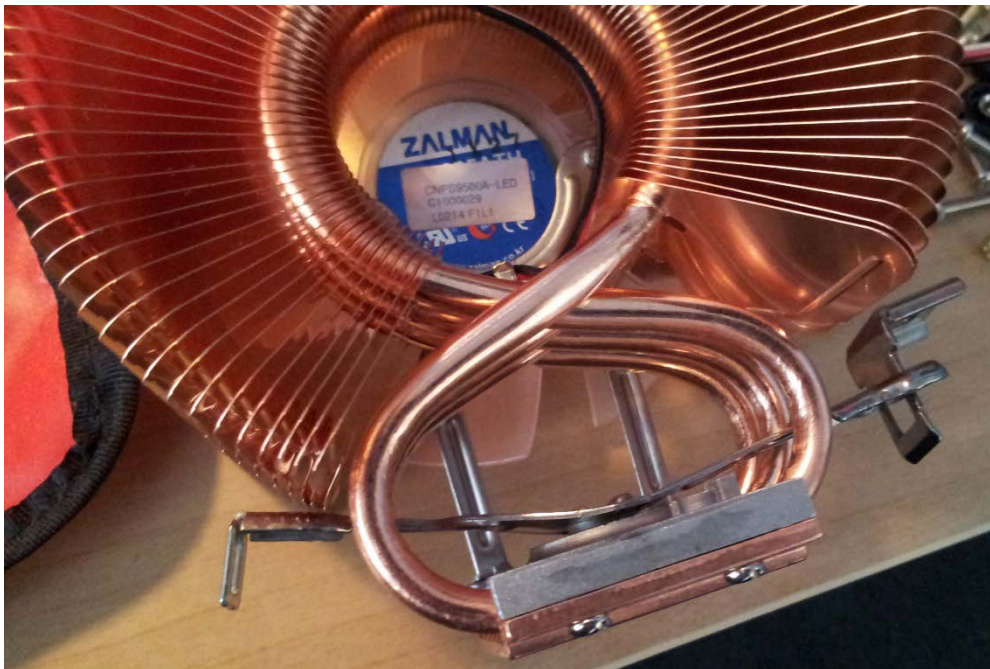
*The CPU cooler attaches by getting one of the clips attached and then forcing the other one down to clip in as well.*

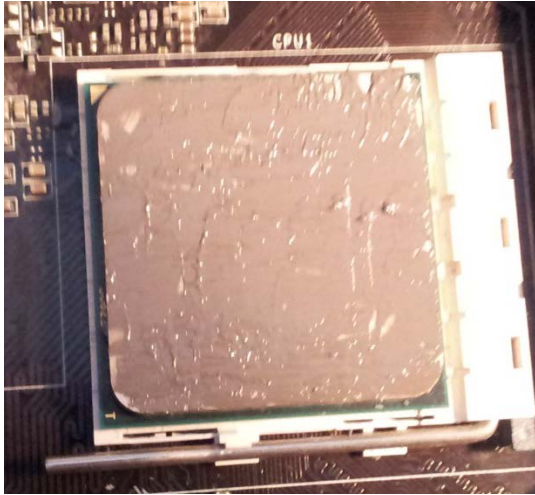
*CPU after Thermal Paste is applied*

Then I start applying the Thermal Paste to the CPU using the card method. I chose the card method (spreading the thermal paste with a card) because it is a lot more reliable at covering the entire CPU with no gaps. The downside to this method is the air bubbles that develop while spreading the paste, these bubbles can ruin the conductivity of the paste in some areas which will heighten the temperature

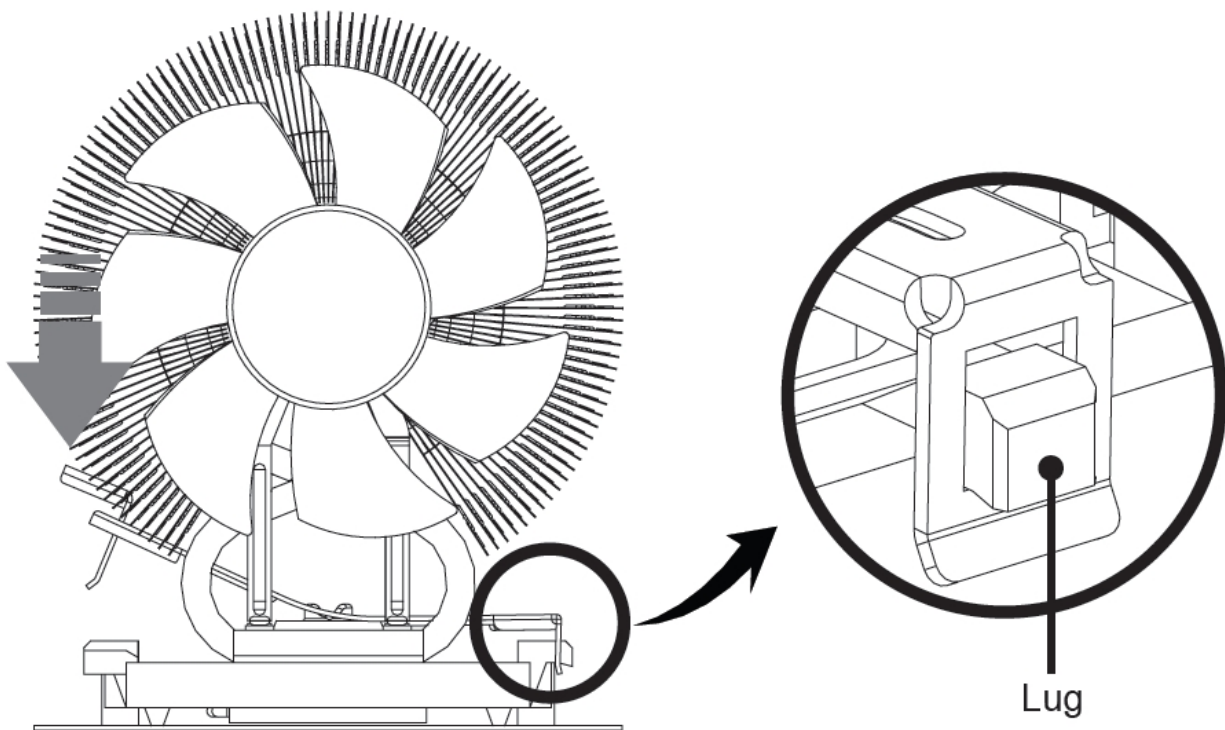
Source: Zalman CNPS9700 / 9500A LED User Manual [\[8\]](#)

I couldn't take pictures while installing the CPU Cooler because I needed both hands to make sure I didn't drop the fan on any of the nearby components. Below is a diagram for the manual [\[8\]](#) that illustrates how to attach the fan.

It was easy to get the first clip attached, but the second took a lot of strength to push into place. I was originally worried that the clips wouldn't secure the CPU cooler enough, but after attaching it I feel that it's very secure.

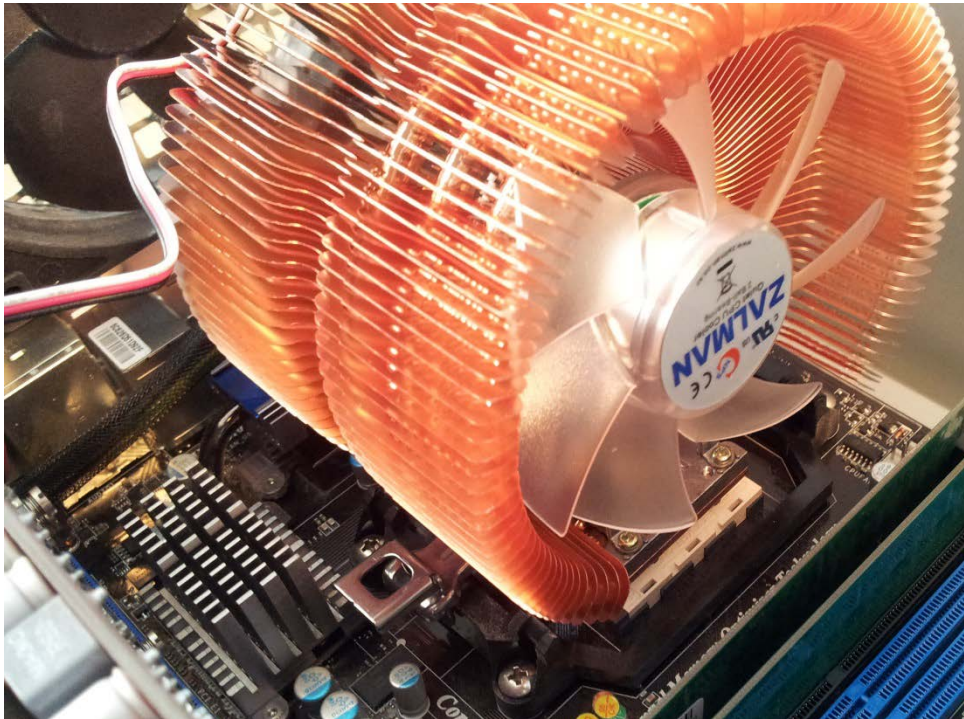
*CPU cooler is attached and secure.*

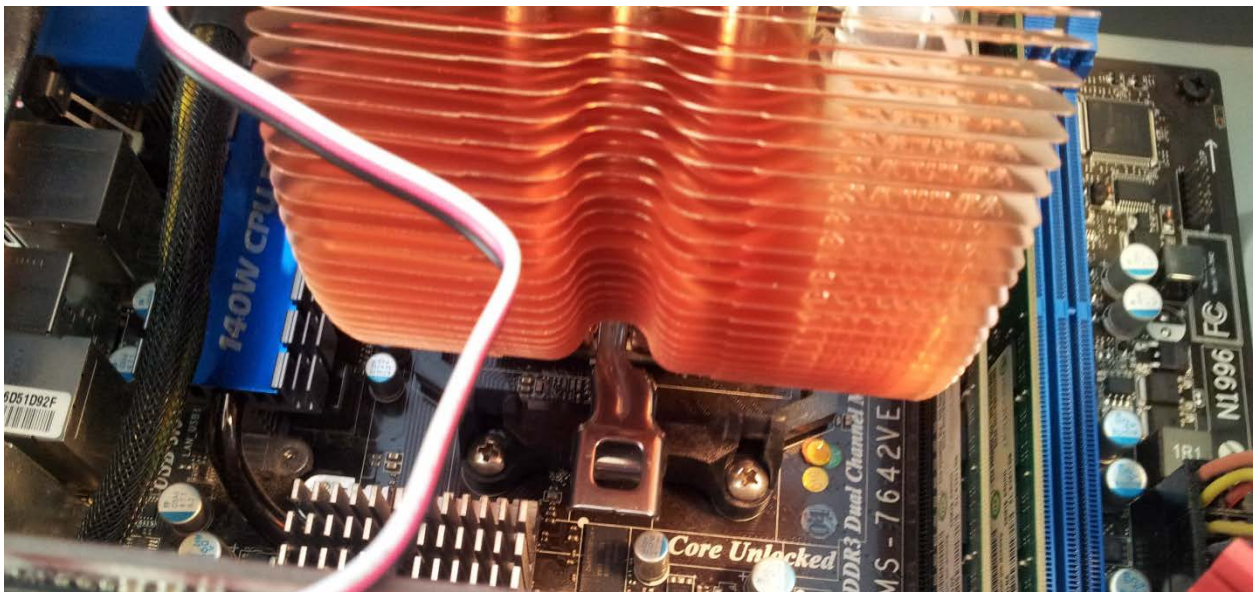
*Close up on one of the push down clips. (Couldn't photograph the other one because it's masked by the cooler)*

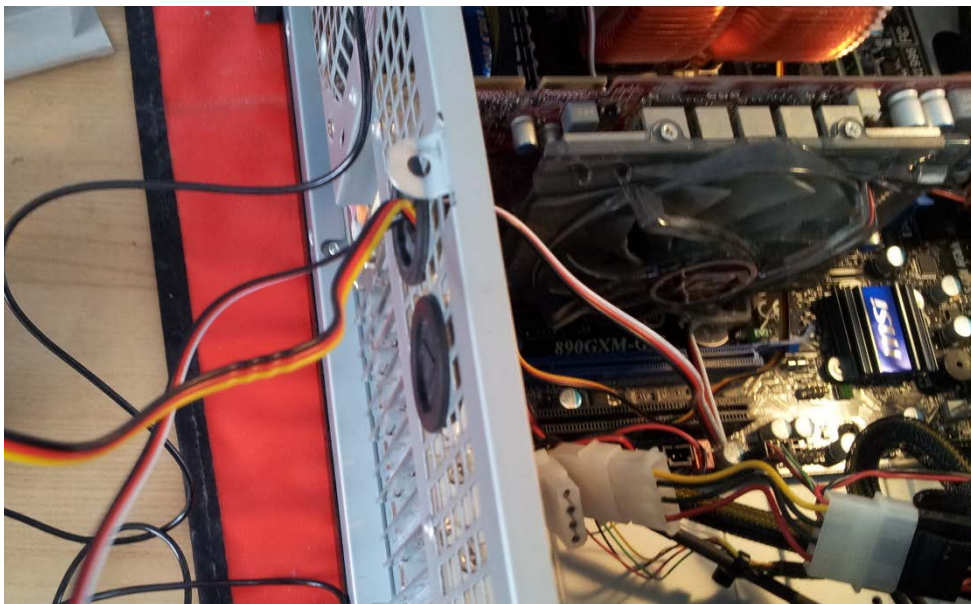
*Fan controller cable running out of the case and back in.*

I attached the Fan controller to the side which does leave the wires running along the outside of the case quite a distance. Some tape could cover this wire, or drilling a hole closer to the fan controller. However there no danger in leaving them like this unless they get damaged.
